Tension testing of green oak  
connections – FRAME 2003, St  
Fagans

Jonathan Shanks

Dr Peter Walker

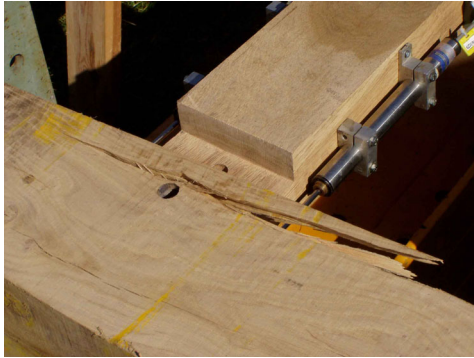
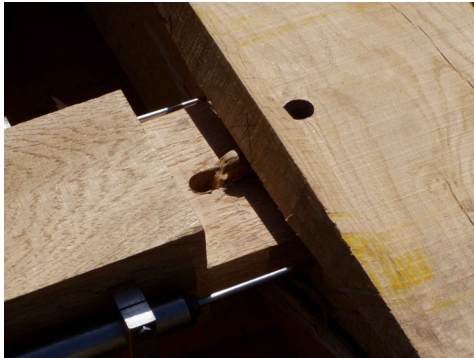
Figure 3.1

1 – Rick Lewis; 1.62 t

Peg yielded, crushed and pulled out between mortice and tenon. As the load increased the mortice wall split where the grain sloped and 'ran' off the timber.

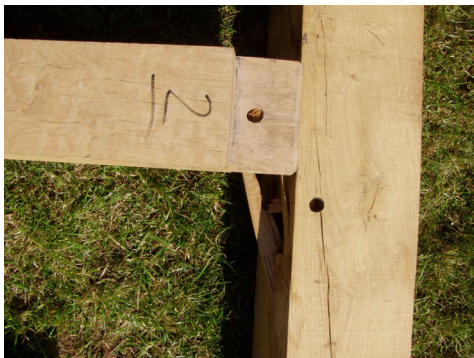
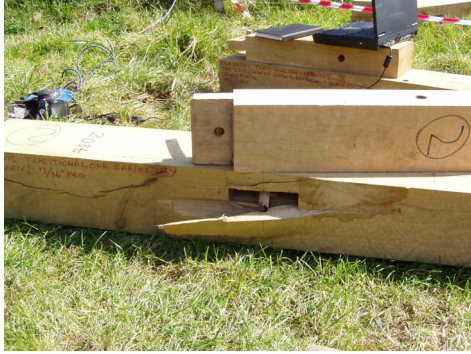
Figure 3.2

2 – Rick Lewis; 1.47 t

Failure mode very similar to 1 except slope of grain very significant in the thicker mortice wall causing splitting of this section

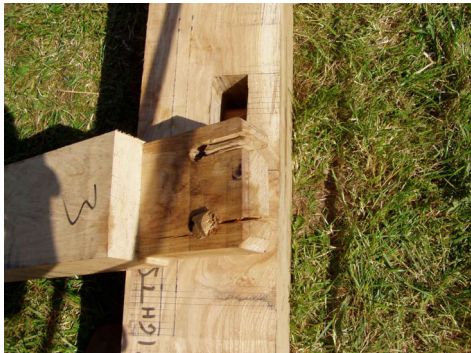
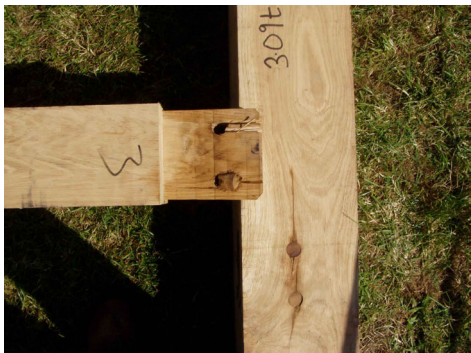
Figure 3.3

3 – Crumps; 3.18 t

Joint remained fairly stiff until approx. 2 t where the relish failed on one of the pegs. The other peg yielded soon after.

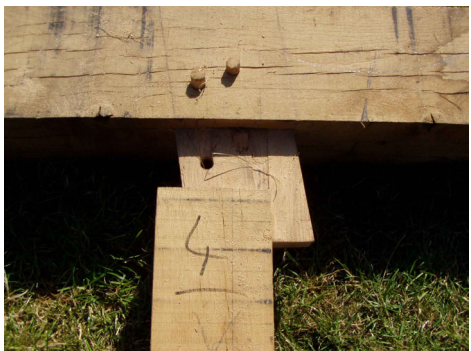
Figure 3.4

4 – Jim Blackburn; 4.05 t

As the dovetail pulled out, so to did the wedge. Pegs crushed and pulled out between m & t.

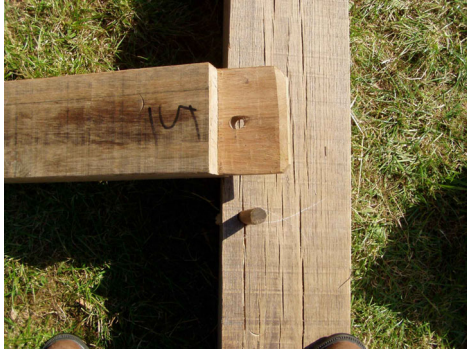
Figure 3.5

5 – COWCo.; 1.44 t

Failure mode as 1 except straighter grain in the mortice wall caused mortice wall to split but crack did not run out of the timber.

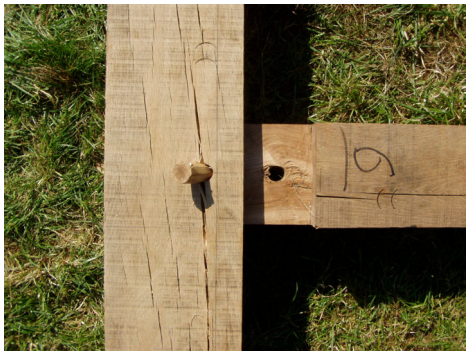
Figure 3.6

6 – COWCo.; 3.13 t

As above

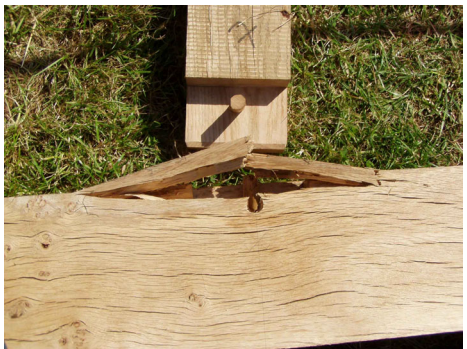
Figure 3.7

7 – Carpenter Oak; 1.61 t

Peg yielding, crushing and pulling out then mortice wall splitting. 'Wavy' grain led to mortice wall lifting and 'bursting'.

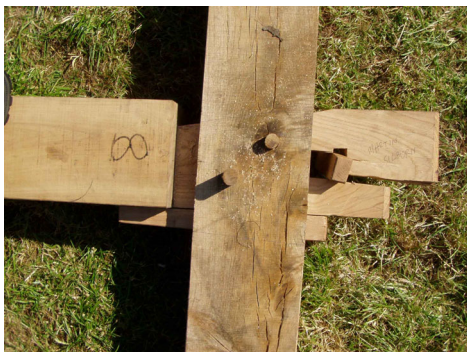
Figure 3.8

8 – Martin Silburn; 8.64 t

Very stiff connection. Brittle failure occurred in combination of tension and shear of the plane between the pegs.

The stiffness of the joints, illustrated by the load at 1 mm displacement, is far more indicative of the performance of the connection in situ. This shows that Martin Silburn's connection would be more suitable than 9 – Peter Eyles (COWCo) even though 9 carried a higher peak load. At peak load 8 had displaced 6 mm and at the same load 9 had displaced 27 mm.

However, the other characteristic to consider is the ductility of the connections. Consider Martin's connection loaded in a frame. If the load approached the ultimate failure load (if, say, inadequate safety factors in design) then the failure would be instantaneous with no warning. This is very undesirable in structures. With this in mind, the most suitable may well be Jim Blackburn's half wedged dovetail, which exhibits a 'hardening' or stiffening after the initial loss of stiffness giving warning of impending failure.

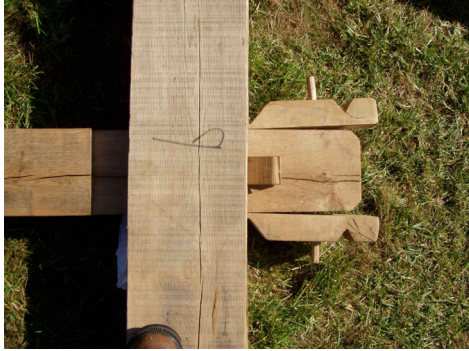
Figure 3.9

9 – COWCo.; 9.91 t

Maintained a high load for a very large displacement. Wedge in tenon pulled through between m & t. When Load released 8 x 8 'beam' member split along entire length.

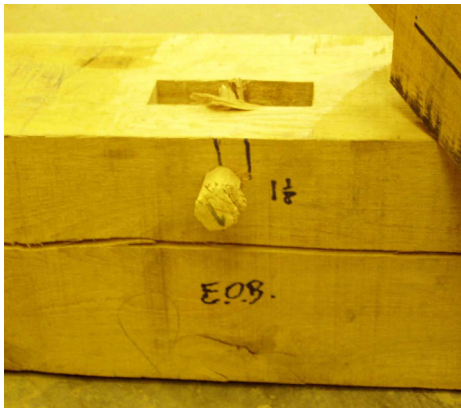
Figure 3.10

10 – English Oak Buildings; 1.15 t

Very similar failure as seen before. Peg yielded and pulled out between m & t.

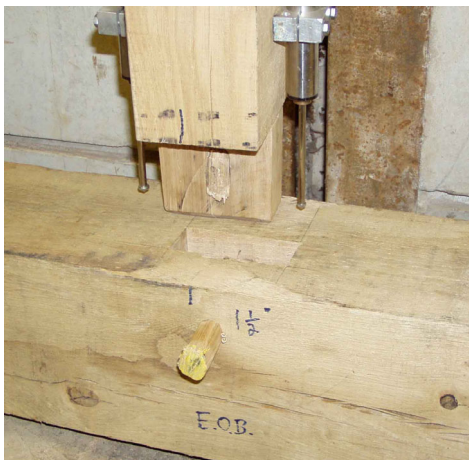
Figure 3.11

11 – English Oak Buildings; 1.20 t

Failure mode as above.
