Tension testing of green oak  
connections – FRAME 2003, St  
Fagans

Jonathan Shanks

Dr Peter Walker

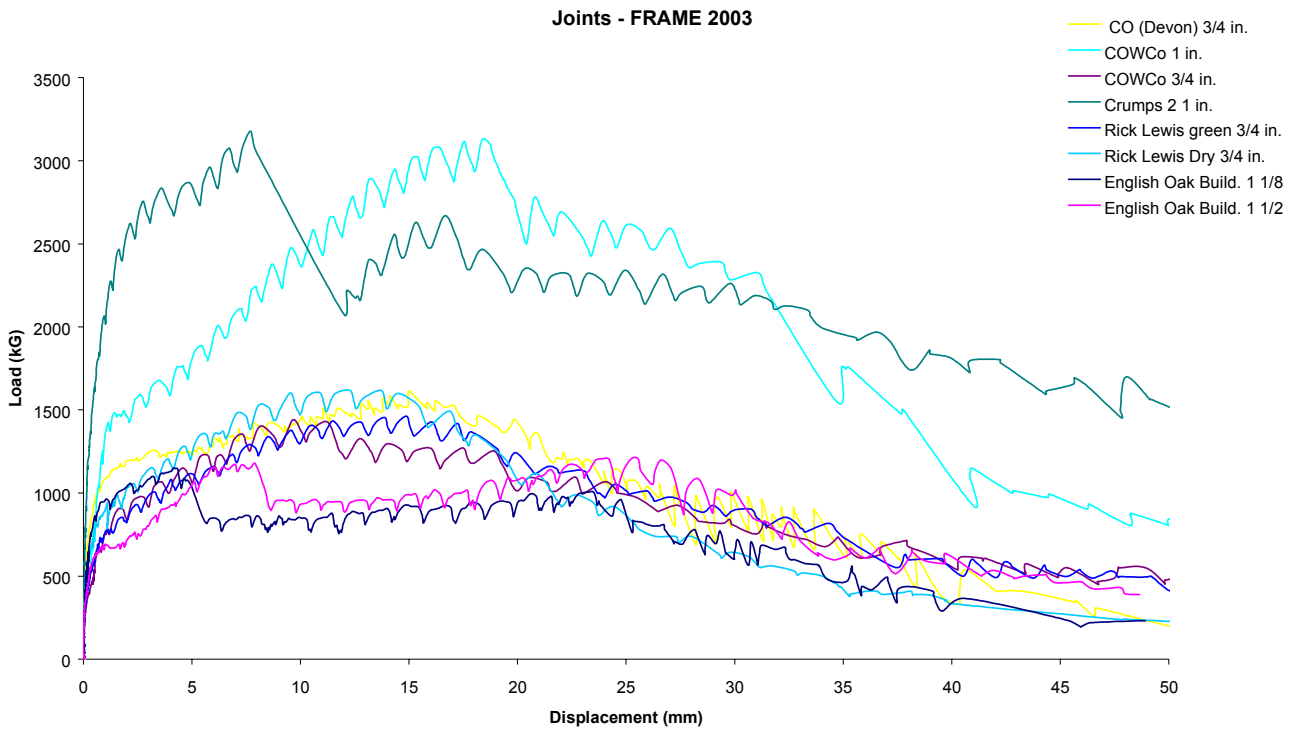
Figure 3.12 – Load/displacement graph for the pegged connections

The simple pegged connections exhibit an initial stiffness followed by a loss of stiffness, then another increase before complete failure. This behaviour is caused by the peg; initially the peg carries the load elastically, eventually the peg yields, failing in combined bending and shear. Following this the peg is pulled between the tenon and the mortice walls and effectively wedges the connection. In a structure the joint will have been deemed to have failed after the initial elastic failure.

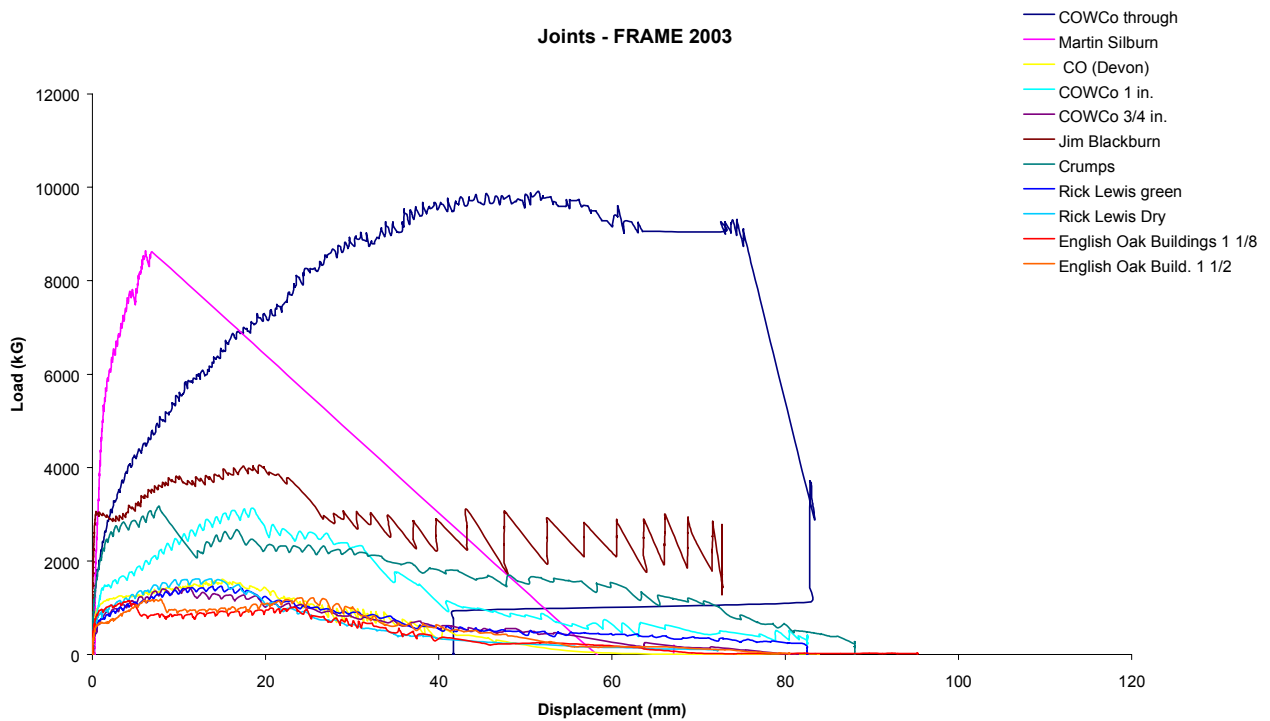
Figure 3.13 – Load/displacement graph for all eleven connections

However, the other characteristic to consider is the ductility of the connections. Consider Martin's connection loaded in a frame. If the load approached the ultimate failure load (if, say, inadequate safety factors in design) then the failure would be instantaneous with no warning. This is very undesirable in structures. With this in mind, the most suitable may well be Jim Blackburn's half wedged dovetail, which exhibits a 'hardening' or stiffening after the initial loss of stiffness giving warning of impending failure.
